CALIFORNIA INSTITUTE OF TECHNOLOGY

EARTHQUAKE ENGINEERING RESEARCH LABORATORY

STATIC AND DYNAMIC TESTS OF A FULL-  
SCALE STEEL-FRAME STRUCTURE

August 1965

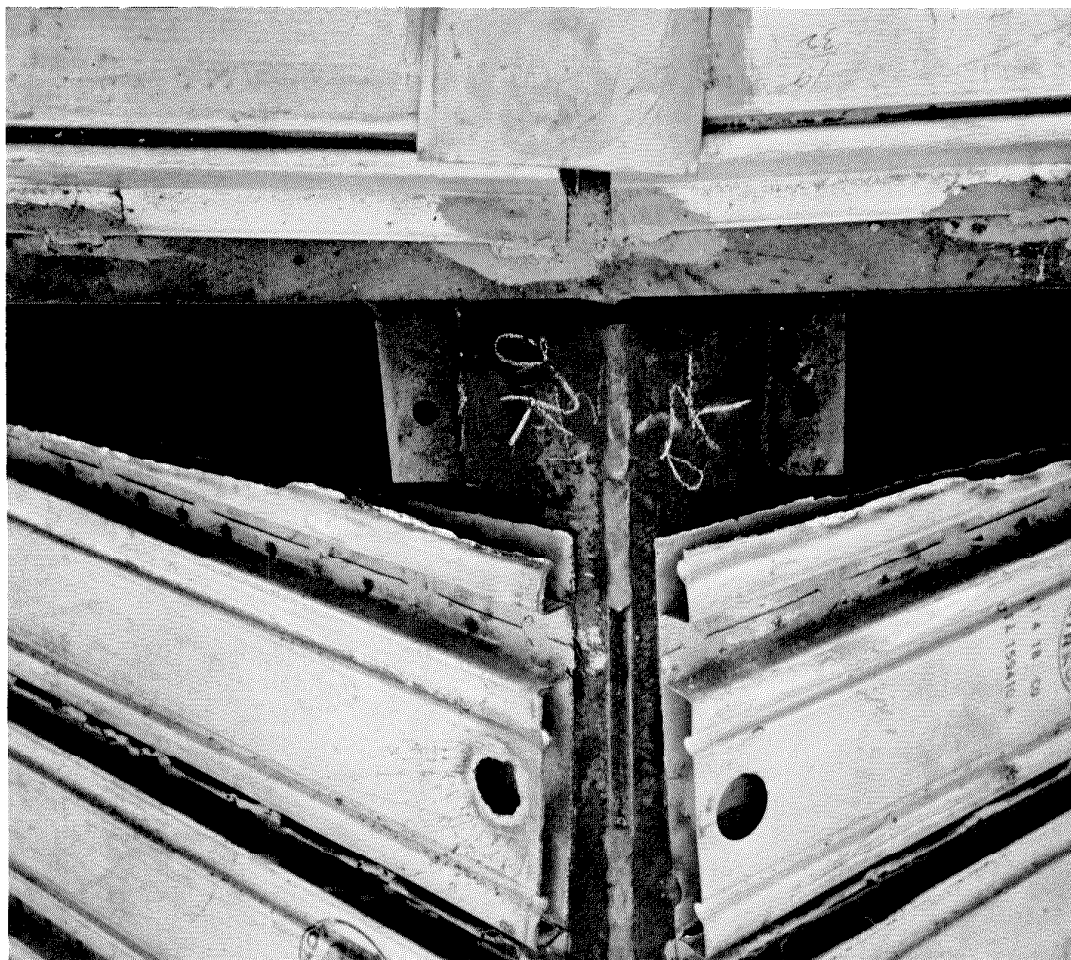
Figure 3. Connection at equipment room.

Figure 3 is a photograph of the connection at the equipment room of the roof ridge member before final welding was accomplished. The photograph in Figure 4 shows the roof valley member connection to the equipment room. Note the concrete slab in the equipment room at the valley member connection level. Also the metal deck used to connect the ridge and valley members can be seen in Figures 3 and 4. A view of the gymnasium from the north is given in Figure 5. The exterior walls have been covered with a paper lath supported by metal channels preparatory to plastering.

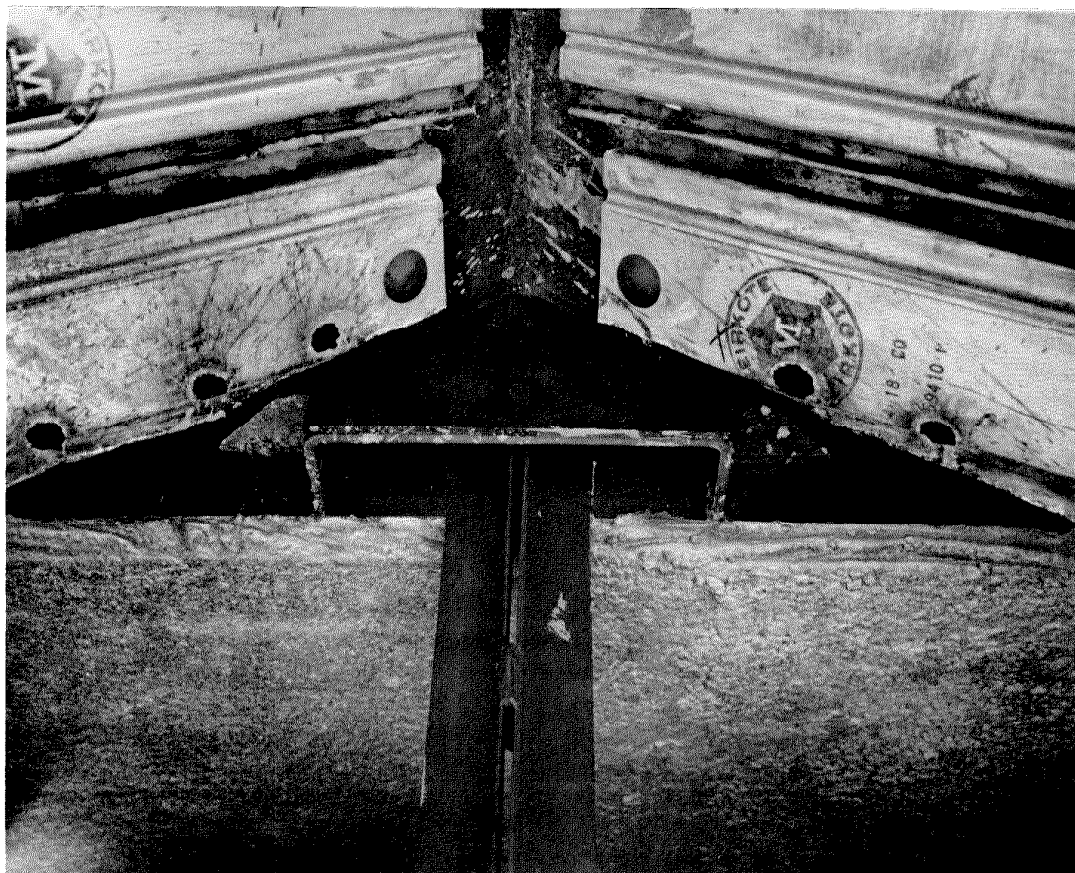
Figure 4.      Roof valley member connection  
                         to equipment room.

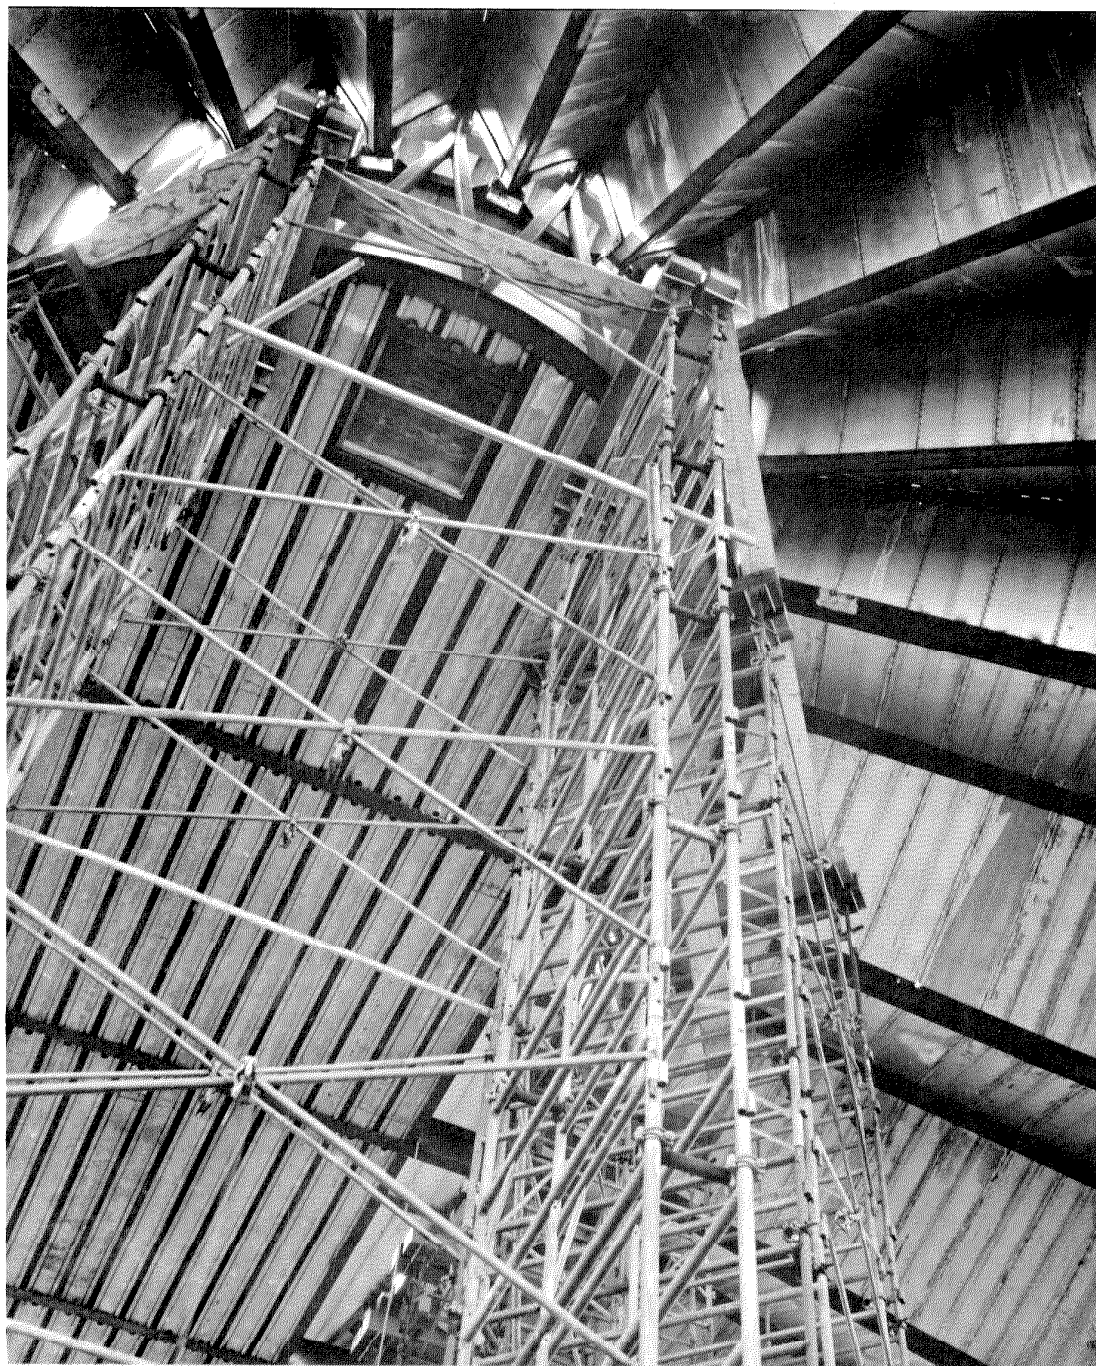
Figure 6.      Roof structure.

At the completion of the roof structure all falsework were removed except those supporting the circumference of the equipment room. Figure 6 shows this stage of construction looking up at the equipment room from the concrete floor. The remaining sections of the concrete floor were placed to provide anchorage for the steel reinforcing bars used to resist horizontal motion of the column bases. A light-weight concrete slab was placed at the intermediate floor of the equipment room. During the last stages of the construction outlined above, strain gages were mounted by Caltech and JPL personnel so that when the contractor was ready to remove the roof support, the strain gages would be operational.

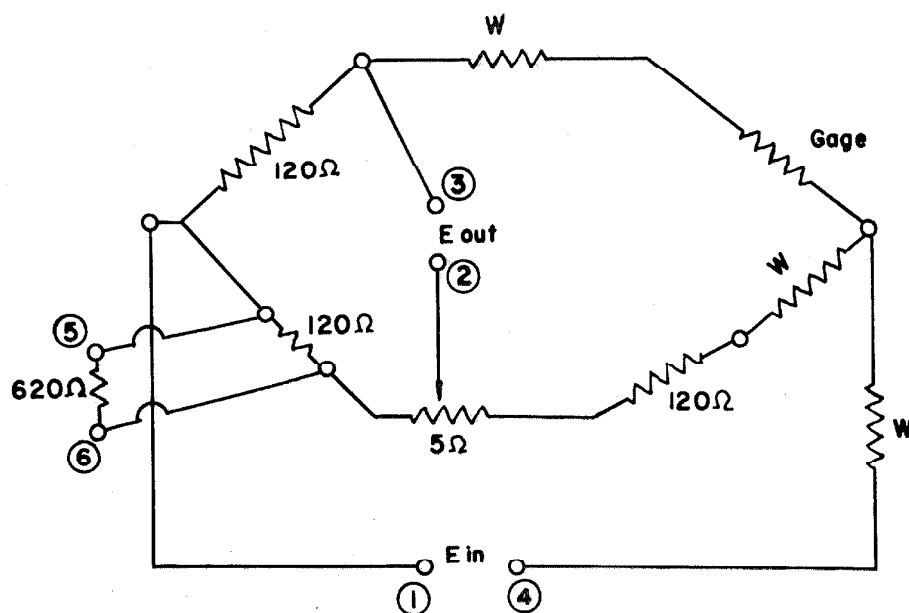
**W = lead wire resistance**

**①... = wires leading to the recording system**

**⑤⑥ = provide calibration shunt connection**

Fig. 7. JPL completion box circuit.

Each strain gage was connected with three lead wires (see Fig. 7) to minimize the lead wire effects. Approximately 100-foot lengths of six-conductor 26-gage copper wire were used between the strain gages and the completion boxes located in the instrument trailer. The loop resistance of the wire was about 8 ohms. The other three legs of the balance bridge were in the completion box with a variable resistor providing a coarse balance of the bridge.

Each completion box unit was connected to one channel of the automatic recording system with a six-conductor cable as indicated in Fig. 7. The fine balance of the bridge circuit was made with this unit. One D. C. amplifier was used to excite four bridges.

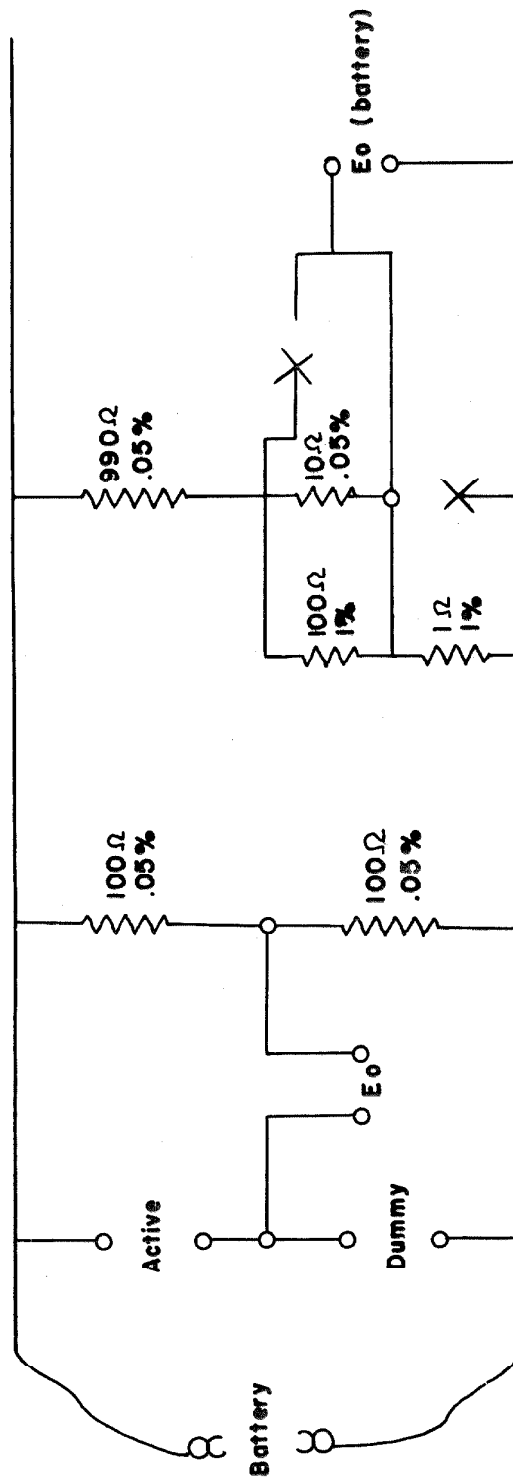
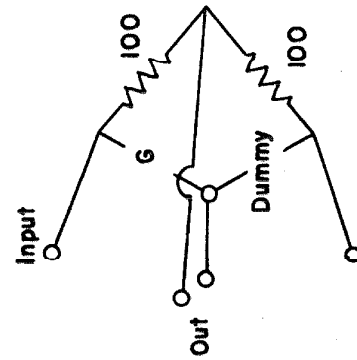
Fig. 8. Caltech switch box circuit.

The active and dummy gages were connected on adjoining legs of a balanced bridge switch box with approximately ten feet of six-conductor 26-gage copper wire. The switch box had a capacity of 20 channels of which only 12 were used in this investigation. Figure 8 shows the circuit diagram of the switch box and the 1000 to 1 voltage reduction for the battery voltage read-out in millivolts. A polarity switch was also provided on this switching unit so that all voltages could be read as positive. The voltages were read and recorded manually from a 10mv full-scale Speed-O-Max voltmeter unit. The power supply was a nickel cadmium battery whose voltage was read at the beginning and end of each data scan.

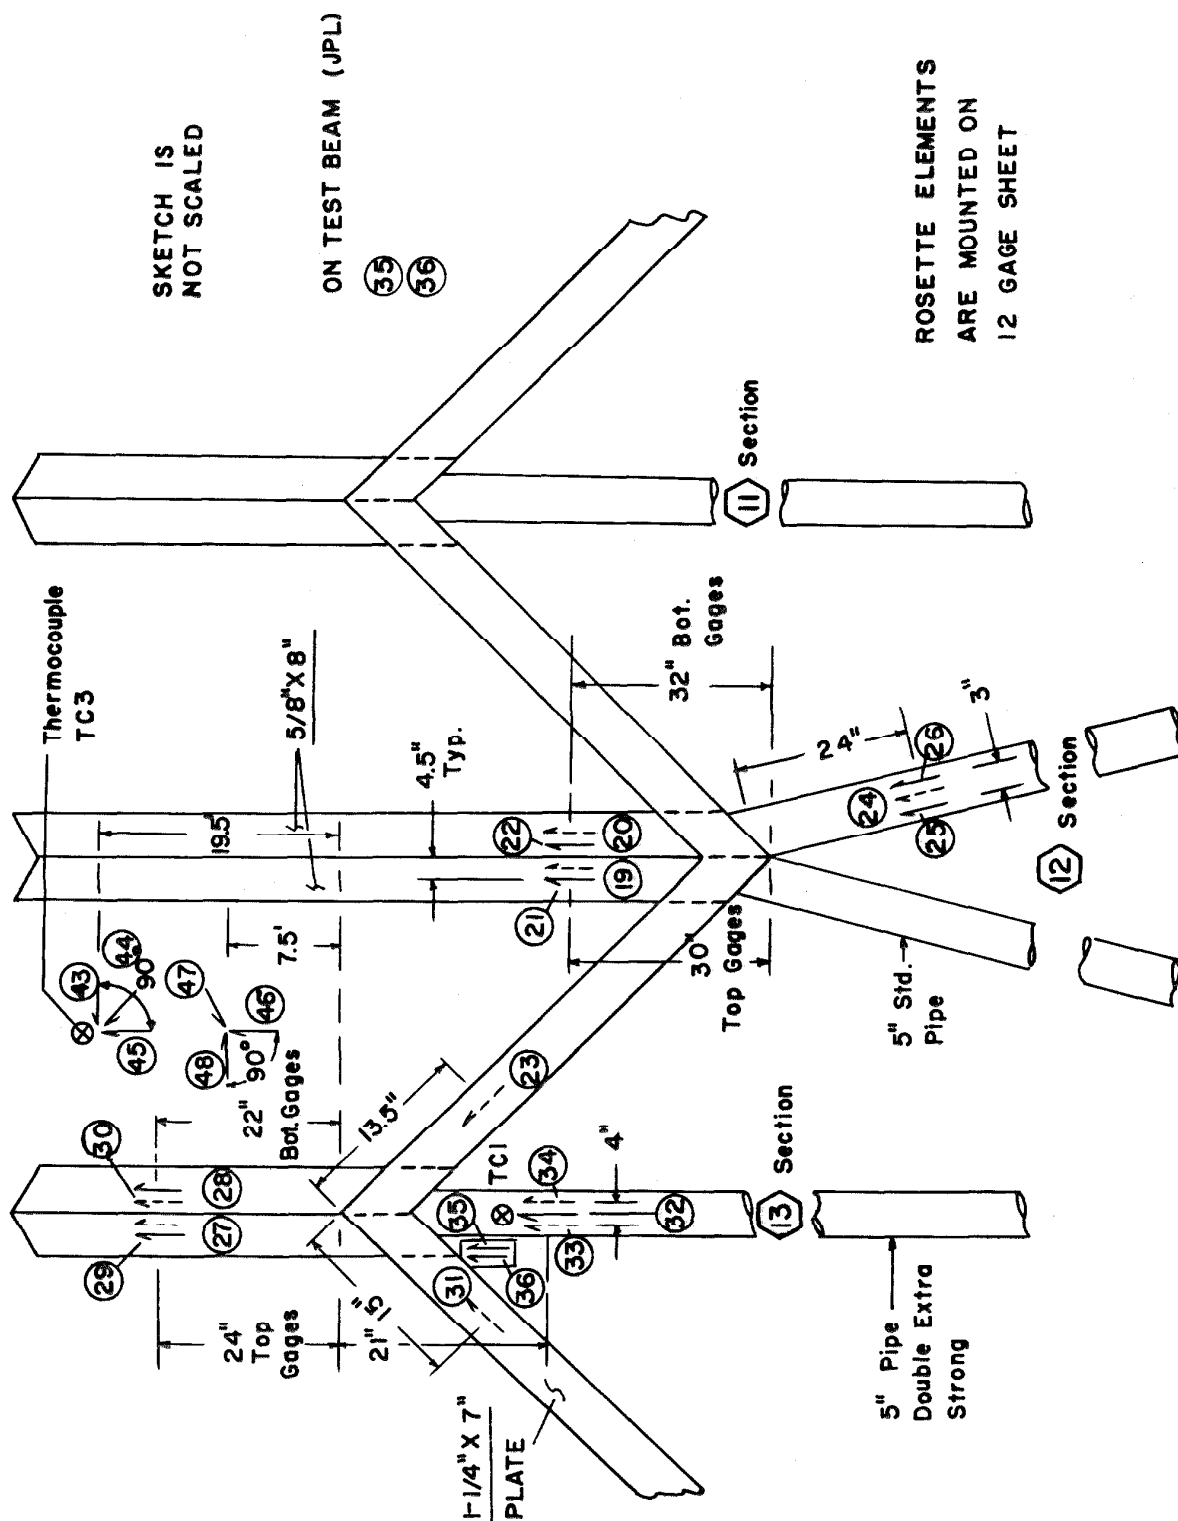
Fig. 9. Location of gages.

The location of the single element gages are given in Figs. 9, 10 and 12 where the dashed lines are used to indicate gages placed on the "interior" side of the member. The column position numbers are related to Fig. 1. Typical gage installations are shown in Figs. 13 and 14. Note that the gage numbers in the photographs are not the same as the tabulated data.

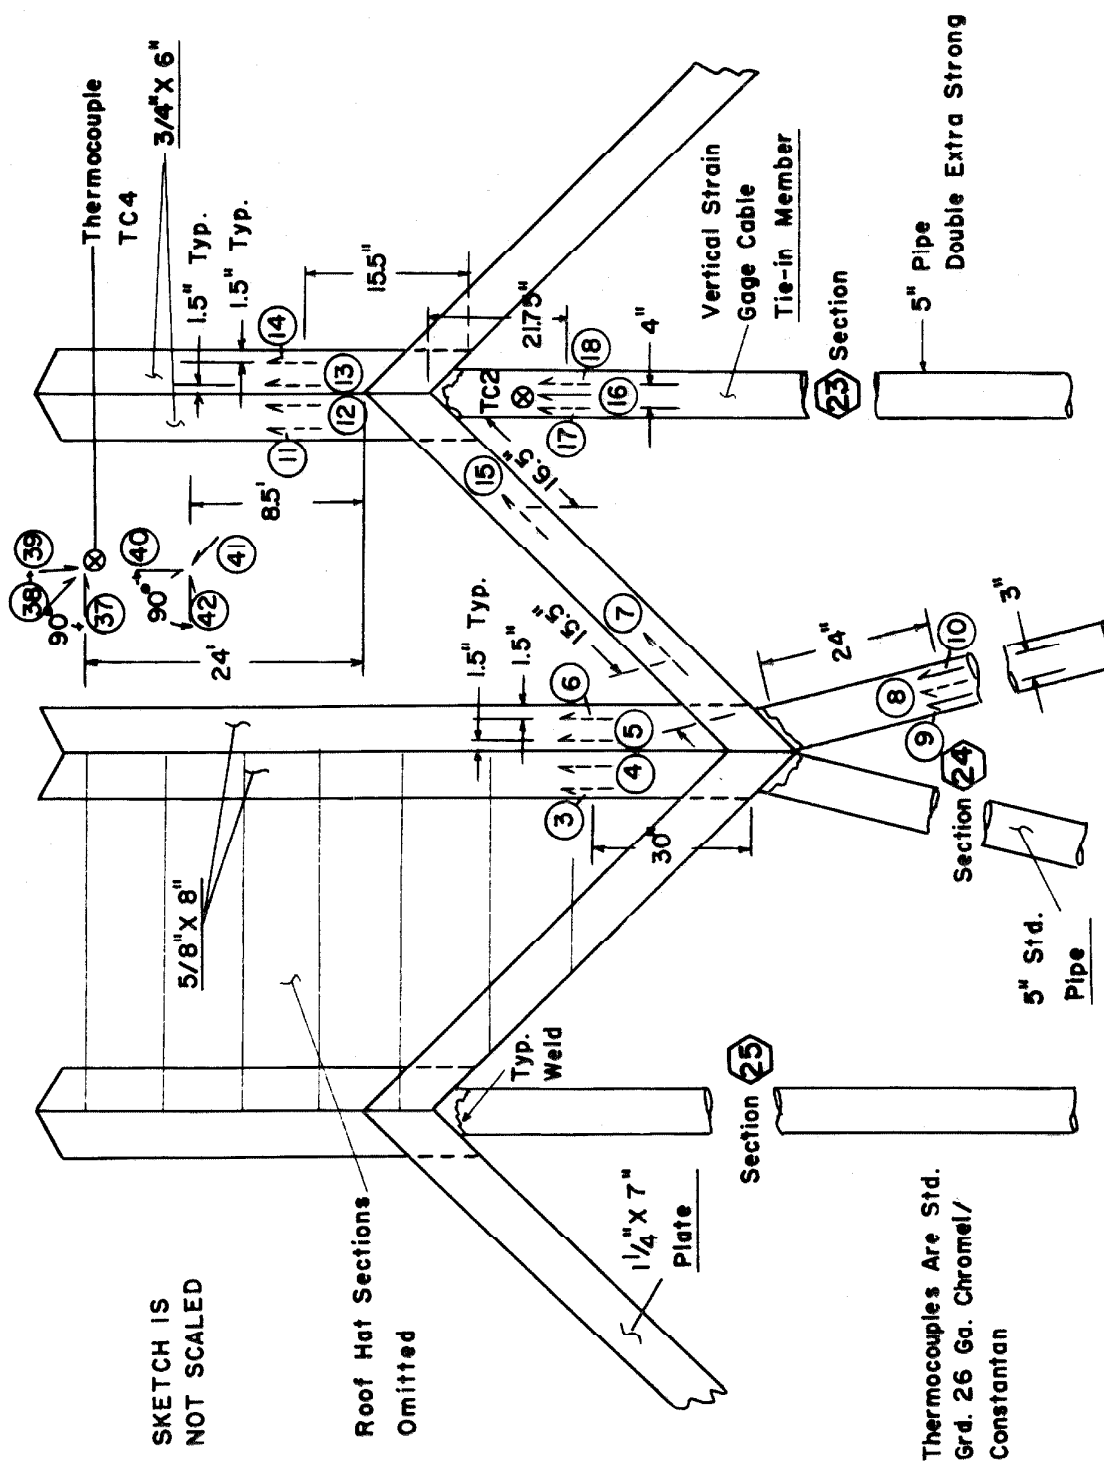
Fig. 10. Location of gages.

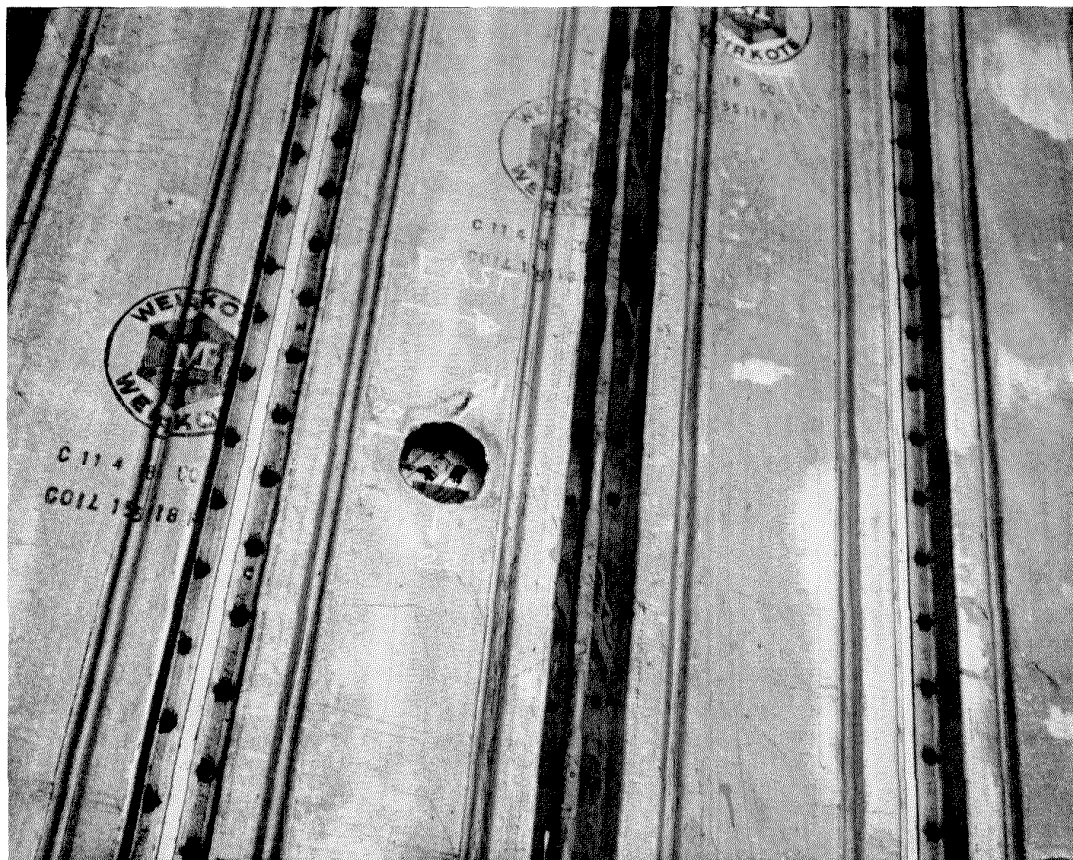
Figure 11. Typical gage locations.

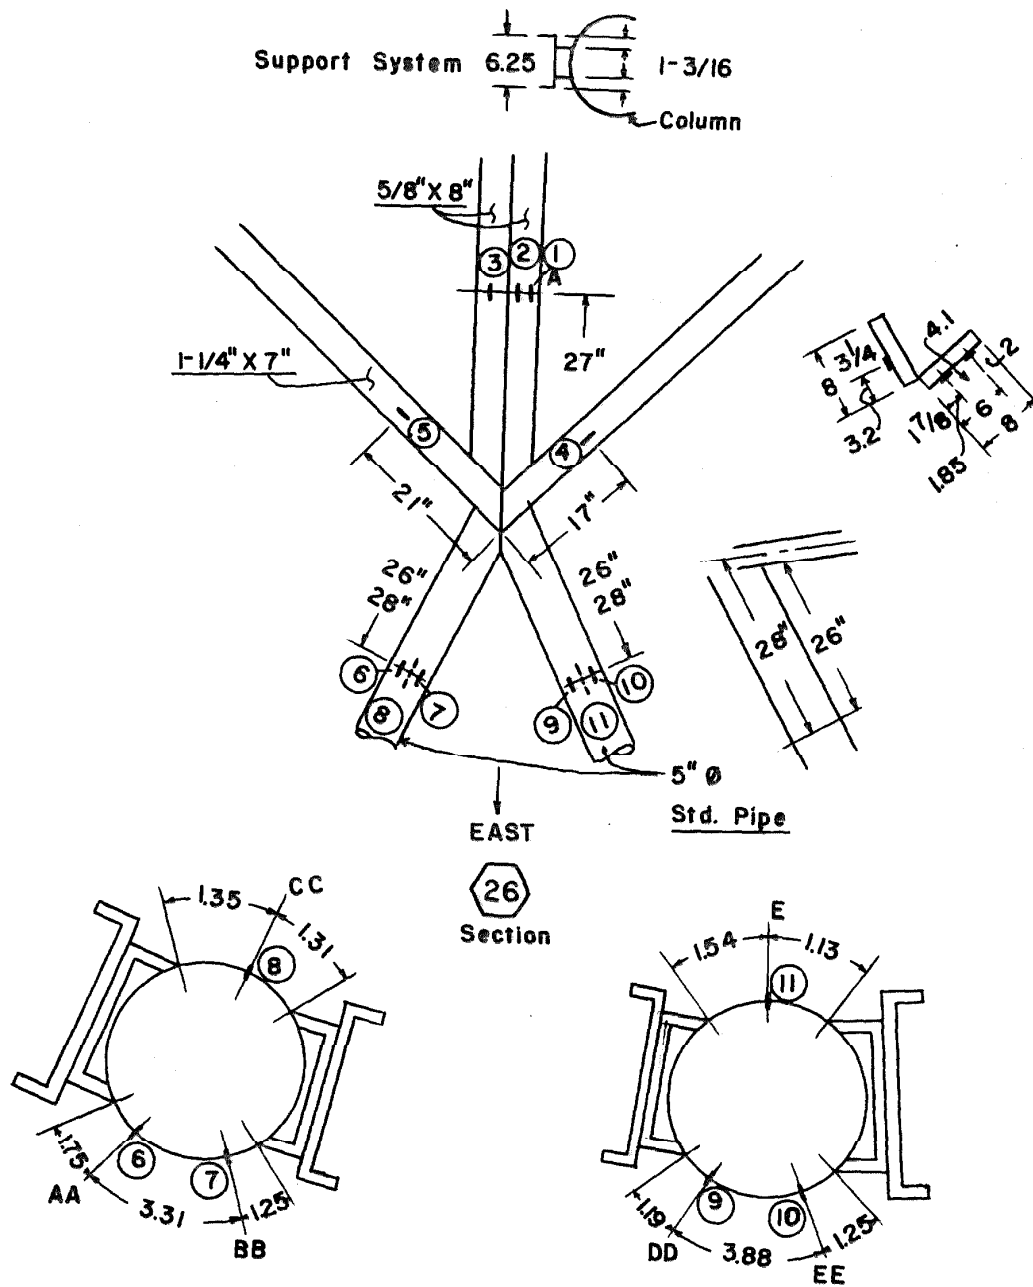
Section Monitored by Caltech

Location: first valley south of east minor axis valley

All gage numbers should be followed by a 'T'

Fig. 12. Location of gages.

Table I presents the reduced data taken with the Caltech instrumentation. The identification of the data channels to specific strain gage locations can be made with Fig. 12. All data is presented in micro-inches per inch. Table II presents the data taken by JPL and the units are micro-inches per inch for the strain and degrees Fahrenheit for the temperatures. These gages may be located with Figs. 8 and 9.

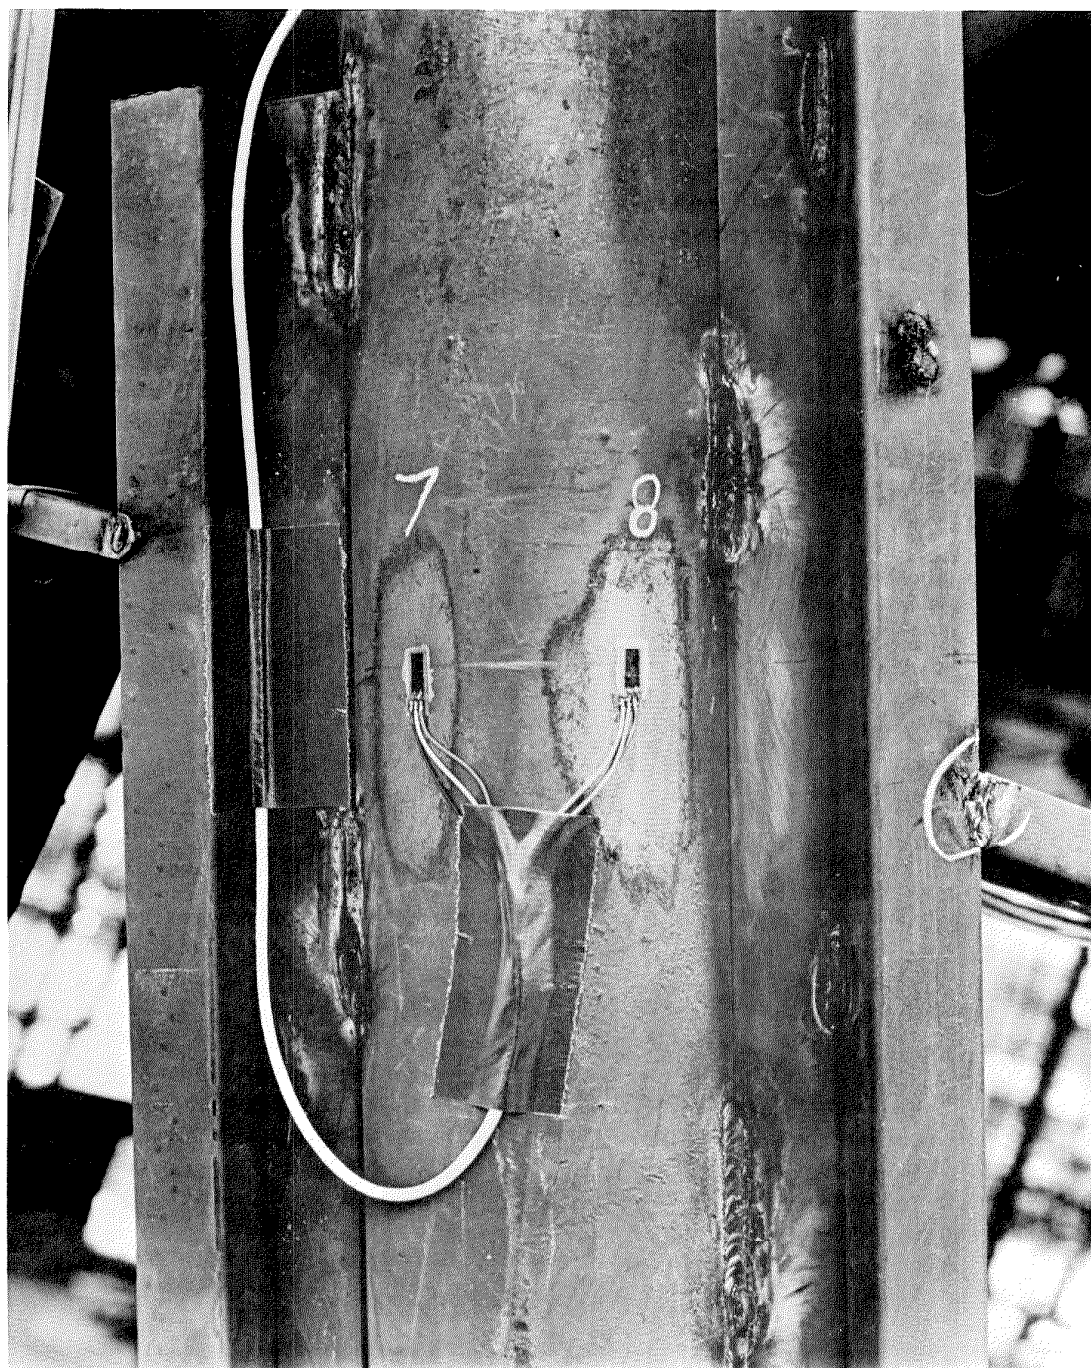
Figure 13. Typical gage installation.

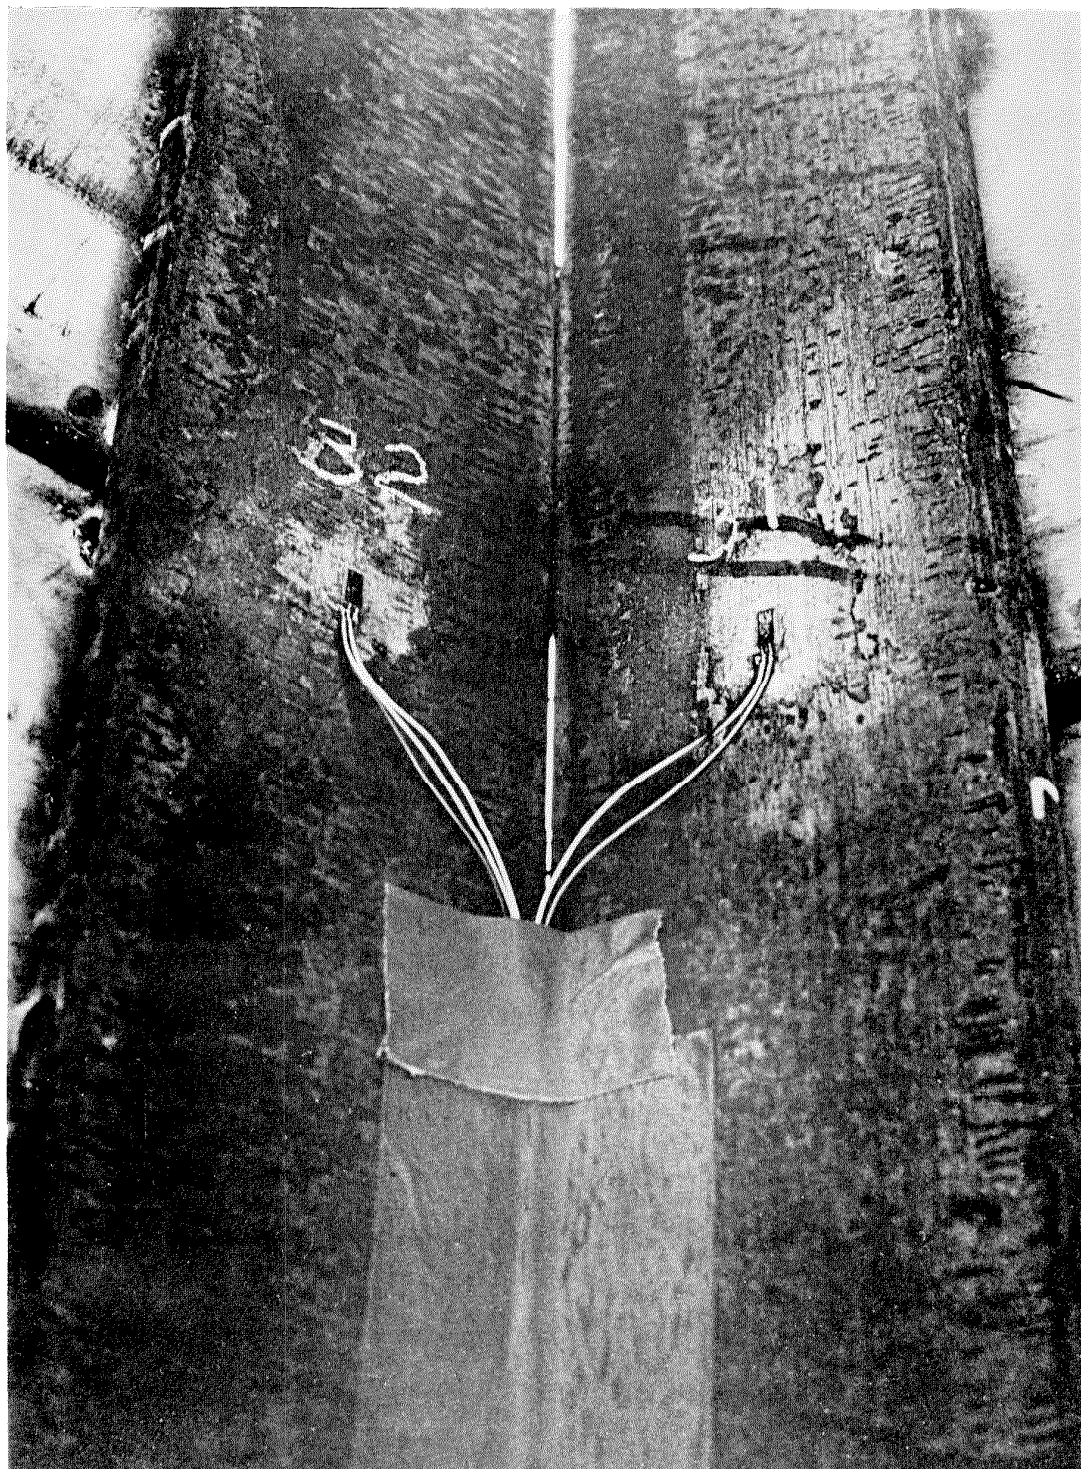
Figure 14. Typical gage installation.

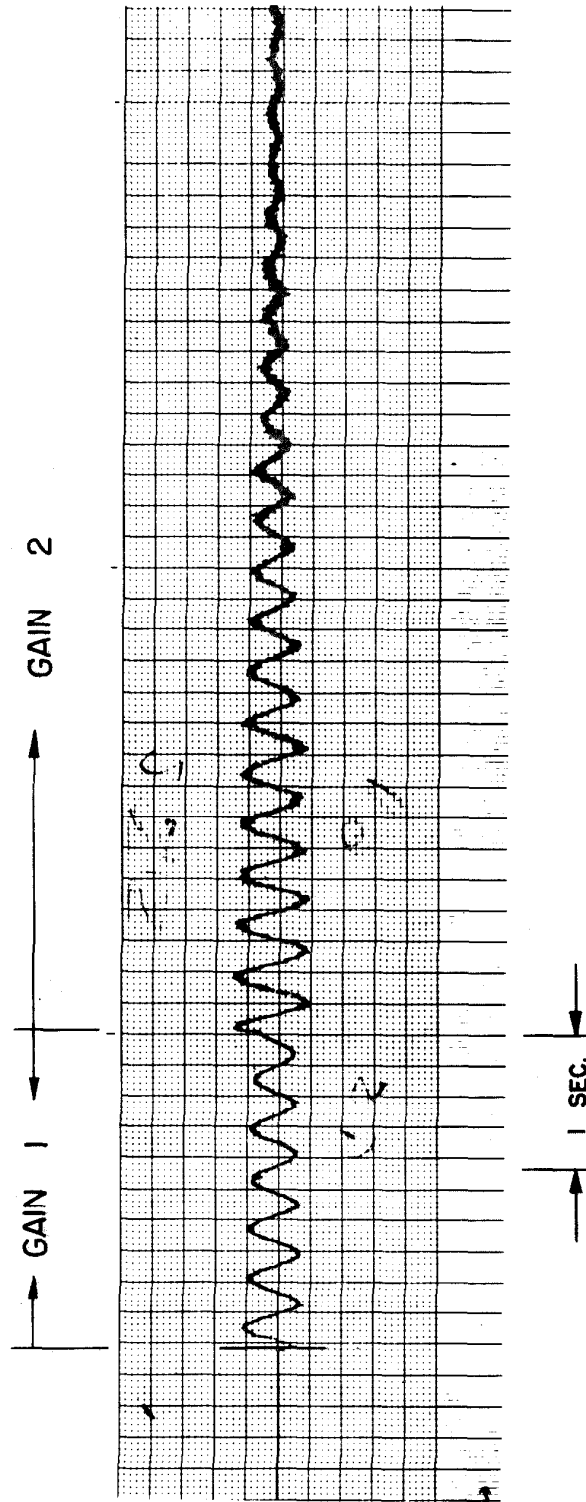
Fig. 15. Man-excited vibration.

A Sanborn dual channel carrier-amplifier recorder Model No. 321-406368 was used to record man-excited free vibrations of the structure. The man-excited vibration was large enough to determine the lowest natural frequency of the structure in the two major directions and to estimate the amount of damping in the structure at small vibrations. The results obtained on 24 June 1965 were: in the North-South direction,  $f_n = 3.50$  cps, damping of 1.29% at a deflection of 0.0007 inches and in the East-West direction,  $f_n = 2.44$  cps, damping of 0.55% at a deflection of 0.0029 inches. Figure 15 shows an example of the type of response recorded from man-excited vibrations.

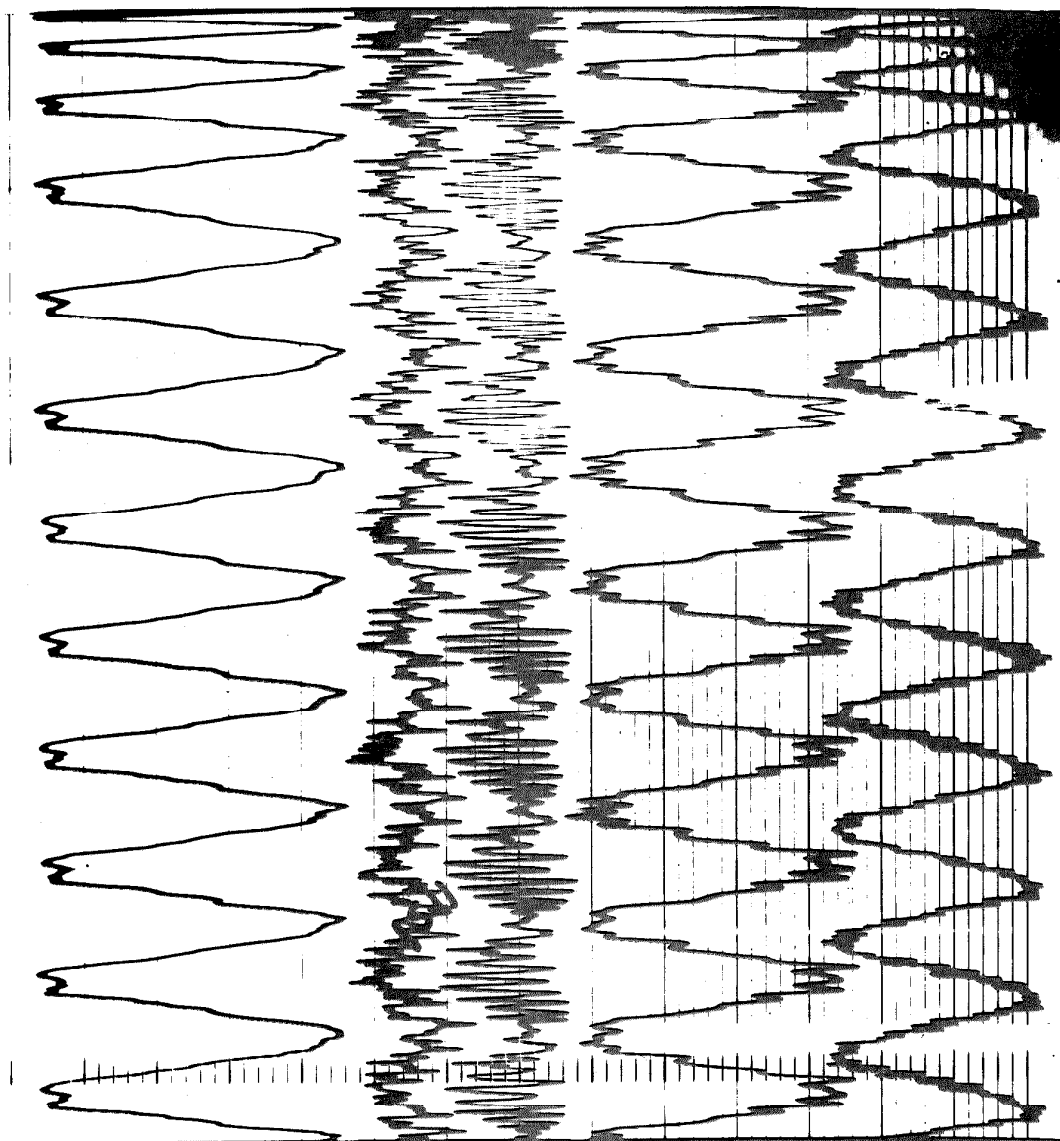
Fig. 16. Typical acceleration record.

The data obtained in the forced vibration studies contained this ambient acceleration because the 40 cps galvanometer was not very effective in filtering a 60 cps signal. The higher frequency signal was averaged out of the data by eye without excessive difficulty in most cases. In the following figures the single amplitude ambient acceleration contained in the data is indicated by the vertical line "I". It should be noted that this does not indicate an error (see Figs. 16 and 17).

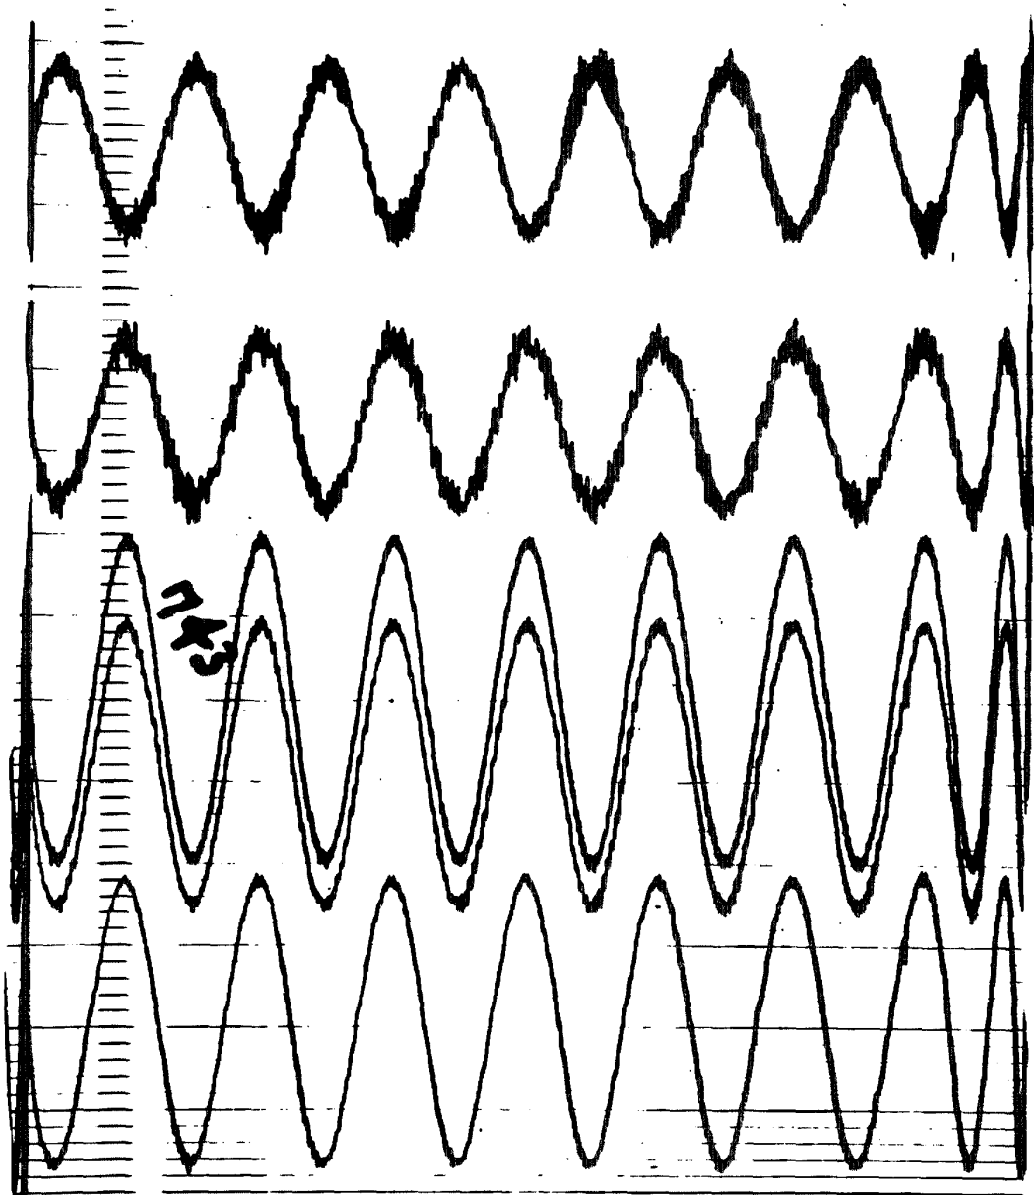
Fig. 17. Typical acceleration record.

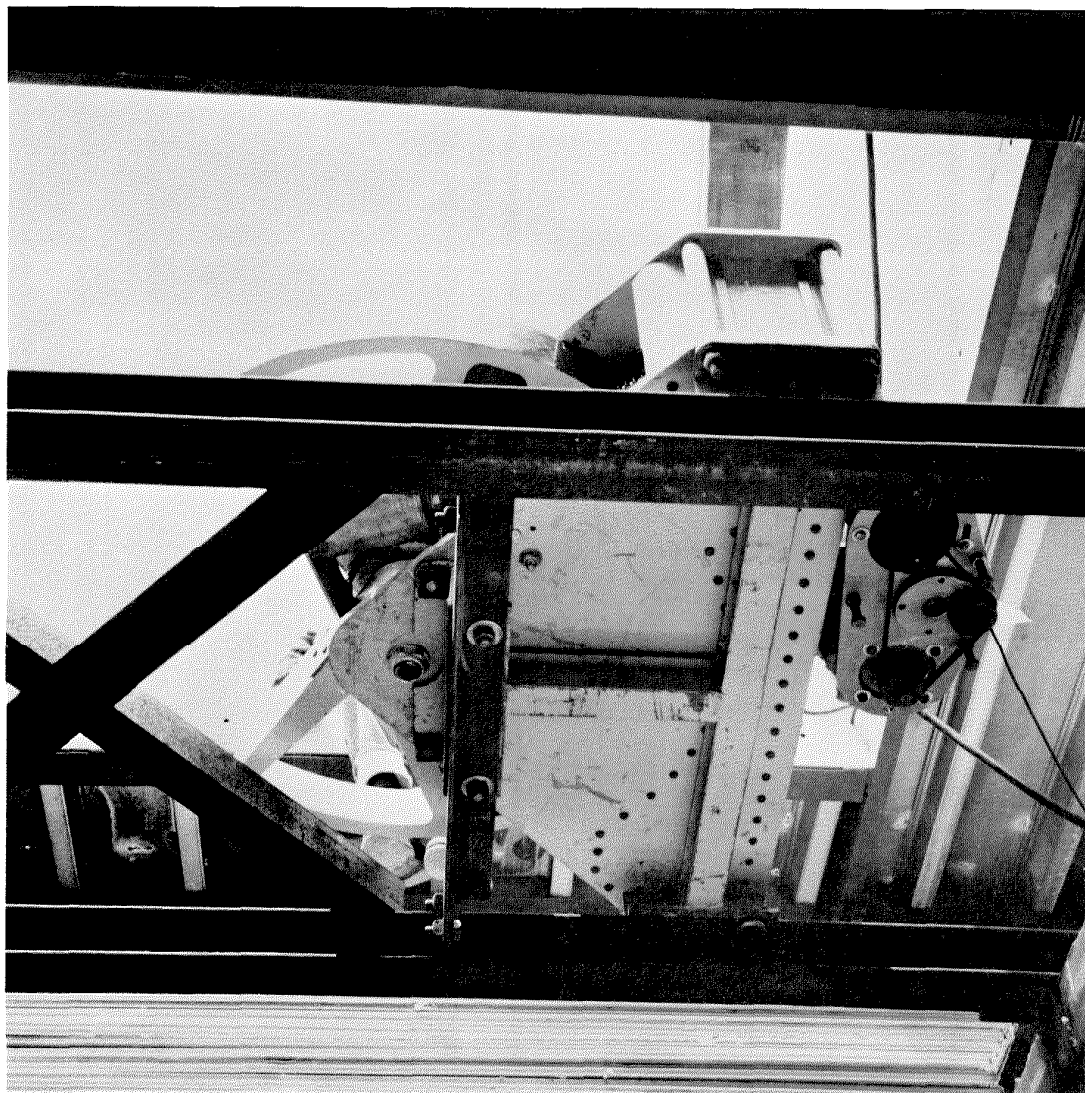
Figure 18. Force generator.

The chain-drive system is driven by a 1-1/2 horsepower D. C. motor through a timing belt which has a 3:1 speed reduction. The drive motor and the tachometer assembly can be disconnected from the generator for easier handling, transportation and installation. A tachometer which gives 100 pulses per revolution was connected to the motor drive system.

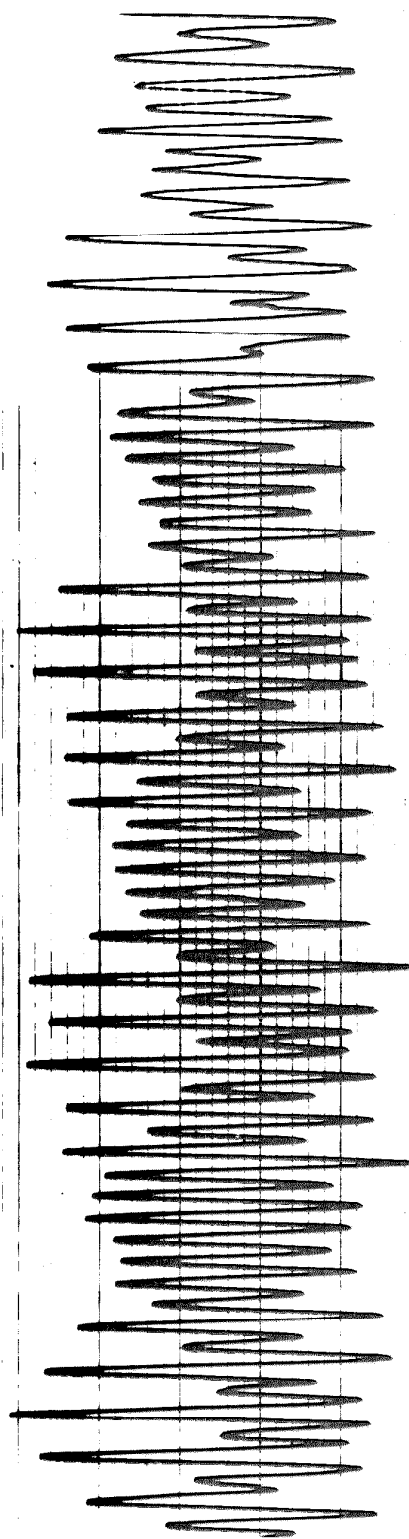
Fig. 19. Ambient acceleration.

Location	Horizontal	Vertical	Comment
On ground at center of Power Plant	0.00072	0.0050	60 cps only (Fig. 19)
On ground at south edge of Power Plant	0.0002	0.00028	30, 60, 100
On ground east of Blair Gymnasium	0.00027	0.00011	"
At lower level of equipment room	0.00131	0.00318	"
At concrete level of equipment room	0.0002	0.00103	(See Figs. 16 and 17)
At upper level of equipment room	0.00148	0.00486	"
Four feet below ridge peak at (20)	0.0030	0.0041	"

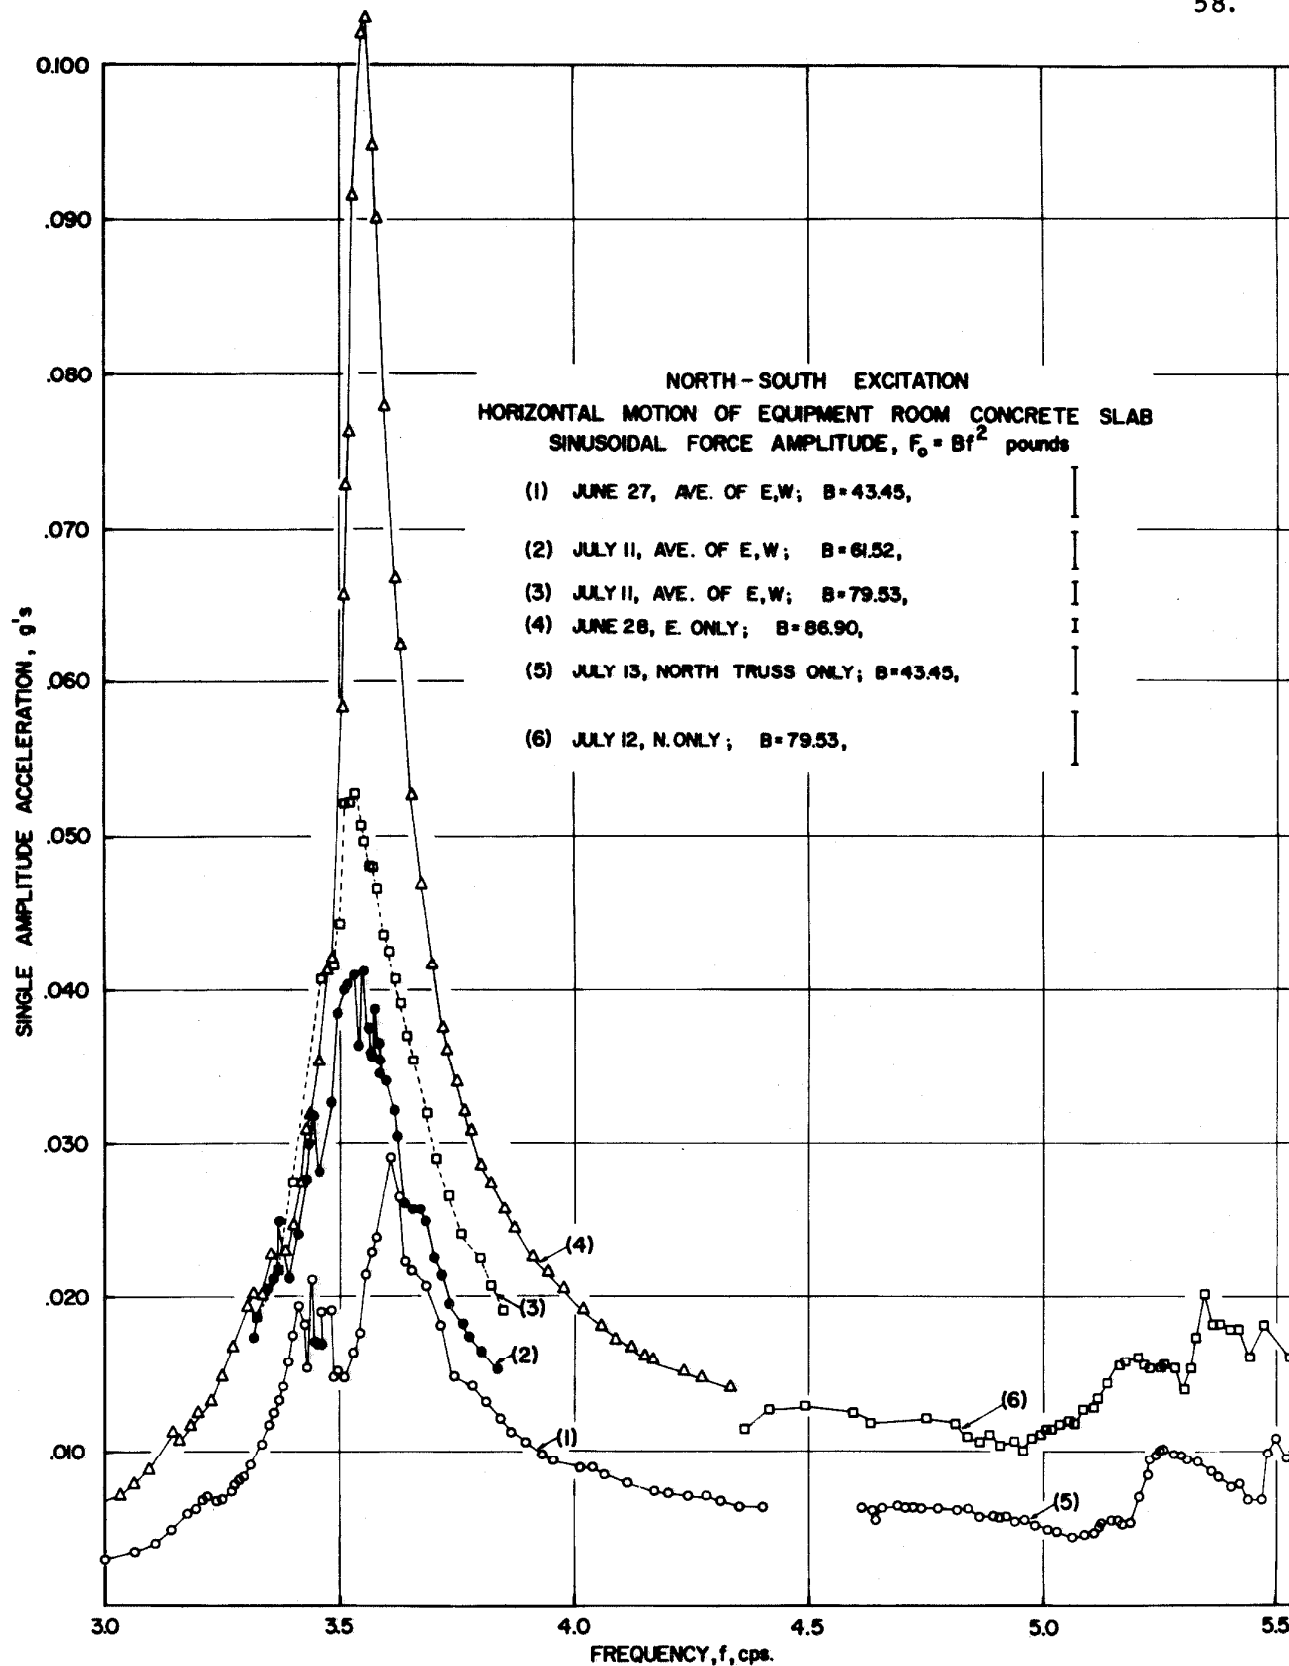
Fig. 20. Frequency response of gymnasium.

Figures 20 and 21 show the frequency response of the gymnasium to excitation in the North-South direction. It should be noted that the response associated with lower natural frequency is a combination of horizontal and vertical motion and that the higher natural frequency mode is predominantly vertical motion at the ends of the equipment room. The vertical motion at the south end was 180 degrees out of phase with the vertical motion at the north end in all tests. The damping calculated by the band width at the half power point of curve (4), Fig. 20, is 1.03 per cent of critical. Figure 22 gives the horizontal response in the East-West direction and Fig. 23 gives both vertical and horizontal response in the East-West direction. The vertical motion at the East and West positions also were 180 degrees out of phase for all tests. The damping calculated by the band width at the half power point of curves (3), Fig. 22, is 1.32 per cent
